Confidential Inspection Report

LOCATED AT:
1270 Valley View Dr
Youngstown, OH 44512

INSPECTED ON:
Friday, October 28, 2016

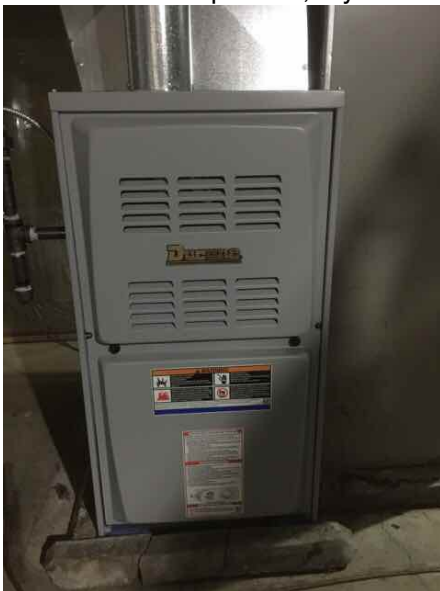
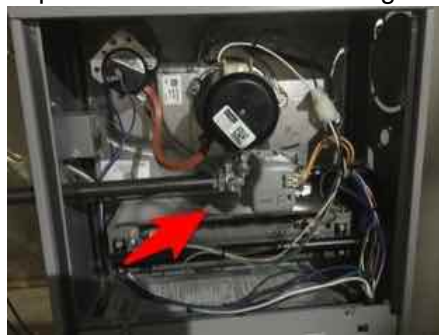
Condensation drip noted, dry at time of inspection. Recommend heating contractor inspect.

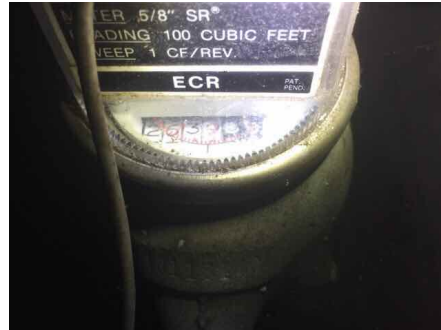
WATER SHUTOFF COMMENTS

- WARN 85:** - The main shut-off valve was located but testing the operation of this valve is not within the scope of our inspection. Operation of the valve from time to time will keep it functional and maximize its useful life. Noted possible leaking of main shut off valve after meter not actively leaking at the time of inspection.

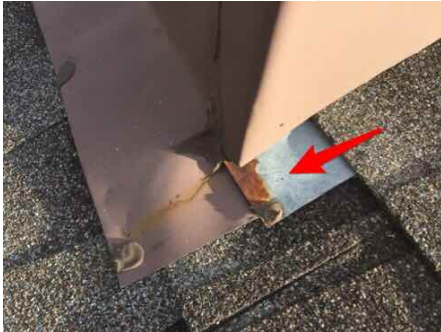
PLUMBING VENTS

100: - There is a plastic plumbing vent protruding through the roof. Standards require this type of pipe be protected and, in most jurisdictions, this has been interpreted to mean painted for protection against the sun. We recommend the vent be painted.

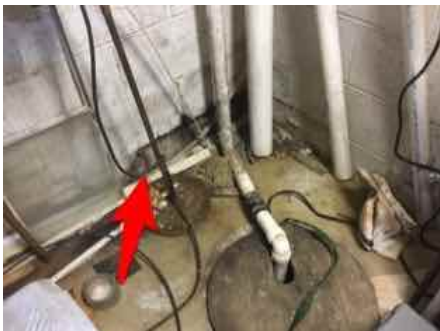
MOISTURE

WARN **108:** - We observed evidence of minor seepage at the sump pump. There was no visible damage observed resulting from this moisture condition present to date. We recommend the area be monitored for additional seepage and corrective measures taken if necessary.

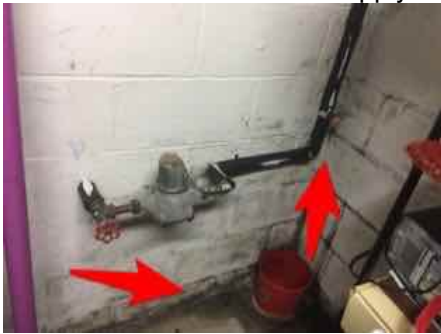
WATER SHUT-OFF COMMENTS

124: - The main shut-off valve is damaged. We recommend it be repaired or replaced.

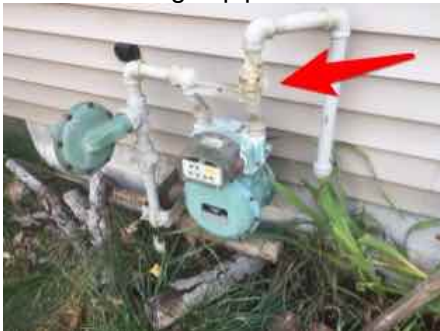
Rust is forming in pipes. Recommend keeping painted.

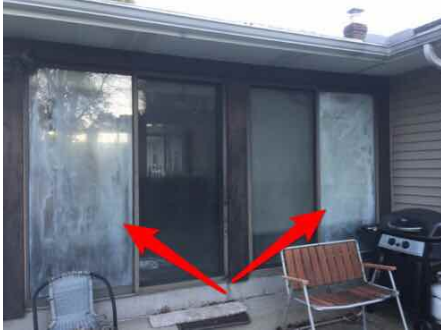
136: - The exterior doors appear to be properly installed and generally in serviceable condition, with exceptions noted below. Florida room glass sliding doors seal broken doors fogged. Recommend replacement with a window door contractor

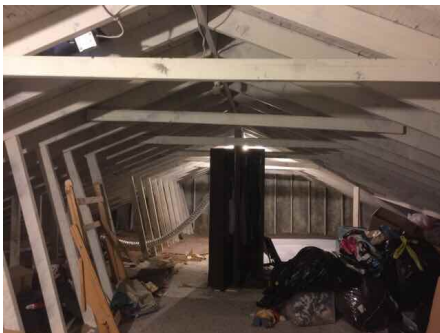
WIRING

WARN 150: - We found exposed wiring in the area near the attic access. Even if insulated, we recommend this wiring be encased in a conduit or otherwise protected in this area, in accordance with present standards. Electrical contractor is recommended for further evaluation.

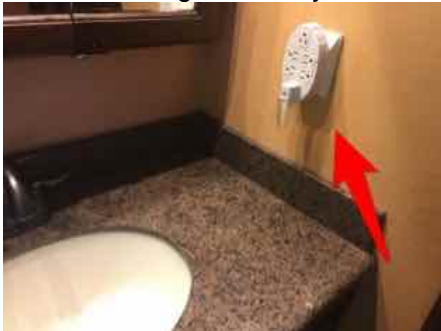
SWITCHES

190: - GENERAL: The three way switch combination is not functioning as intended. This is a matter of convenience and is not a safety problem.

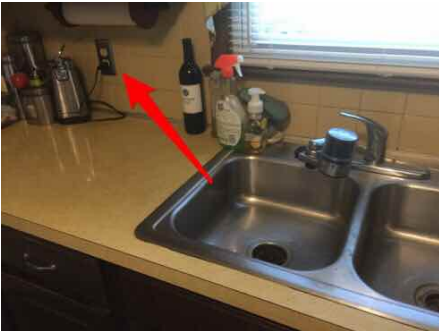
212: - GFCI PROTECTION: There is no GFCI (ground fault circuit interrupter) protection for the 2 countertop receptacle(s) within six feet of the sink. For an increased margin of safety, we recommend the installation of a GFCI receptacle(s).

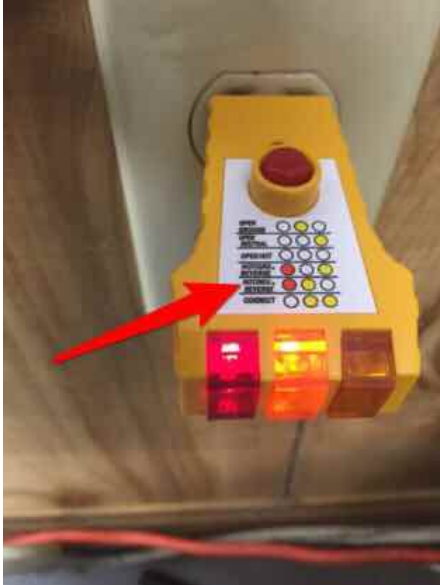
WARN 214: - Several receptacles in this area are wired with reversed polarity. Under some circumstances, this can be a shock hazard and/or damage electronic equipment. It is easy to correct this condition and we recommend the receptacles be repaired.

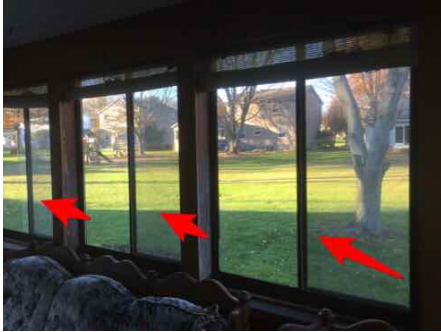
WARN **221:** - Single pane windows. No markings to determine if they are thermal pane. They may be a safety hazard if they are not. Recommend having window contractor evaluate.

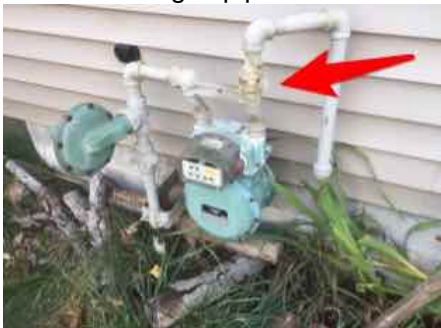
Rust is forming in pipes. Recommend keeping painted.

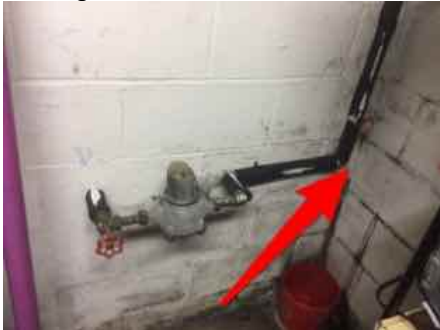
WARN s-1: - The main shut-off valve was located but testing the operation of this valve is not within the scope of our inspection. Operation of the valve from time to time will keep it functional and maximize its useful life. Noted possible leaking of main shut off valve after meter not actively leaking at the time of inspection.

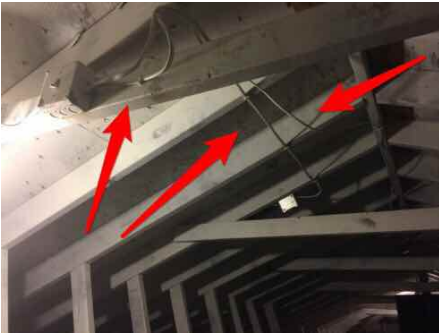
WARN **s-3:** - We found exposed wiring in the area near the attic access. Even if insulated, we recommend this wiring be encased in a conduit or otherwise protected in this area, in accordance with present standards. Electrical contractor is recommended for further evaluation.

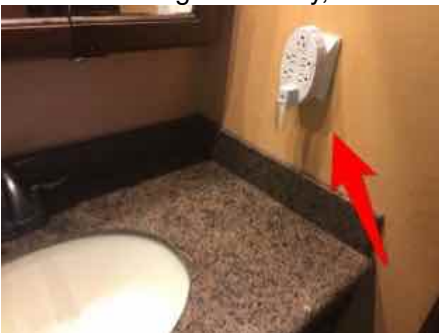
s-5: - GFCI PROTECTION: There is no GFCI (ground fault circuit interrupter) protection for this bathroom. For an increased margin of safety, we recommend the installation of a GFCI receptacle.

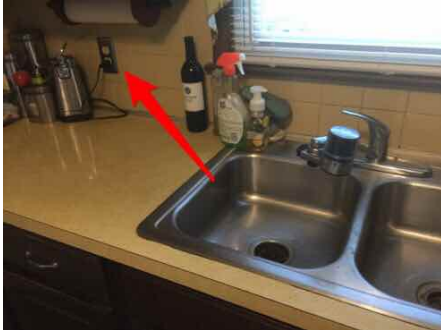
s-6: - GFCI PROTECTION: There is no GFCI (ground fault circuit interrupter) protection for the 2 countertop receptacle(s) within six feet of the sink. For an increased margin of safety, we recommend the installation of a GFCI receptacle(s).

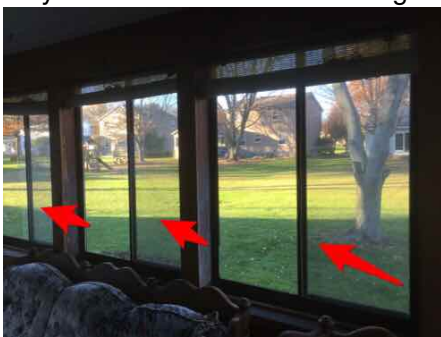
WARN **s-7:** - Single pane windows. No markings to determine if they are thermal pane. They may be a safety hazard if they are not. Recommend having window contractor evaluate.
